**Flood Control Project Maintenance
Levee Inspections**

Fall 2015 Levee Maintenance Deficiency Summary Report

San Joaquin River Basin

Reclamation District No. 2062 Stewart

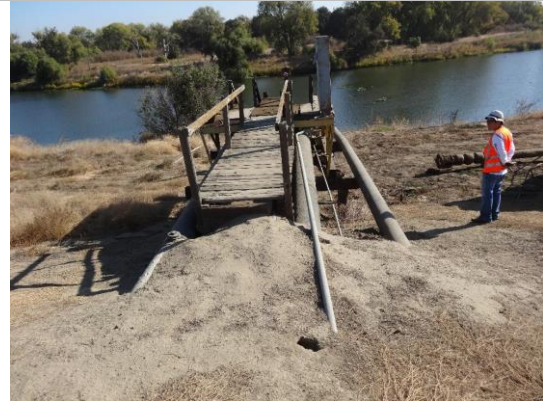
Photo 2 of 3 : UCIP_FA_2015_2094.jpg

LM Start	1.64	Rating **	M	Issue No.	14 (cont)
LM End	1.64	Issue Type +	En	Location *	WS

WS view: 16-inch pipes on both sides of walkway and 10-inch pipe (on right) away from walkway.

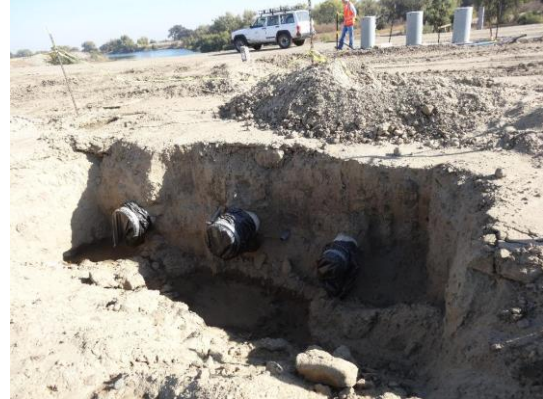
Photo 1 of 3 : UCIP_FA_2015_2096.jpg

LM Start	1.64	Rating **	M	Issue No.	15
LM End	1.64	Issue Type +	En	Location *	WS
Category	Supplemental			GPS Latitude/Longitude	
				Start	End
Item	DWR UCIP Field Study			37.793497 °	37.793497 °
				-121.315340 °	-121.315340 °
DWR ID					
Action/Comments					
Inspector Comments: FS_ID:22810					
DS_ID:19184					
EP_NO: 12679					
FS_HLM: 1.6719					
Repair Type: Non-Urgent					
Crossing Status: Found

LS view: two 16-inch pipes (left) and one 10-inch pipe (right) in ditch.
Concrete box removed.

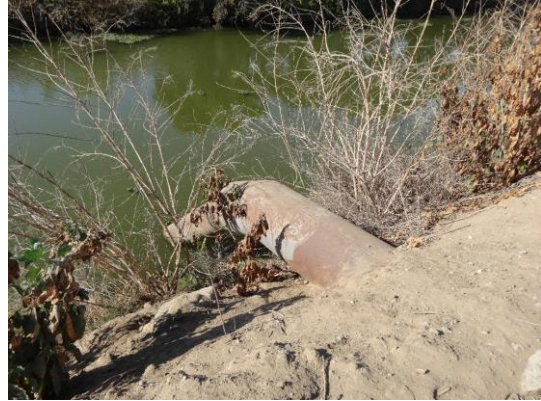
Photo 1 of 3 : UCIP_FA_2015_2154.jpg

Inspector Comments: FS_ID:23110
 DS_ID:24697
 EP_NO: N/A
 FS_HLM: 0.576
 Repair Type: Non-Urgent
 Crossing Status: Found
 UCIP Comments: Found on field with the help of USACE 2012 PI Report. Needs proper abandonment.
 FIELD_STRUCT_DESC: Abandoned 24-inch steel pipe through the levee. Damaged siphon breaker on waterside levee slope. Pump on concrete sump on landside. Service pole on landside levee slope. Pump was disconnected from service pole.
 FS Date: 10/23/2013

WS view: exposed steel pipe on channel bank and also immersed into channel water.

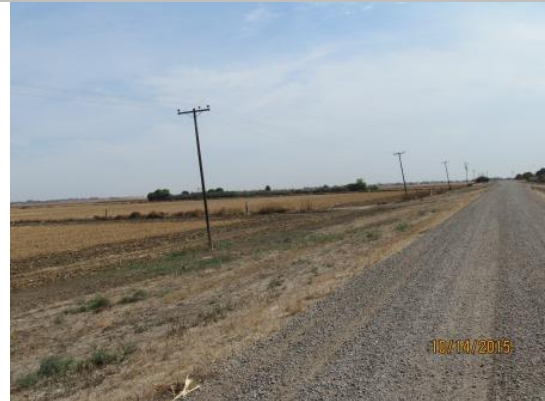
Photo 1 of 1 : FA_2015_RD2062_310_12_20151026_00013.jpg

LM Start	1.88	Rating **	A	Issue No.	12
LM End	1.88	Issue Type +	Ma	Location *	LS
Category	Earthen Levee			GPS Latitude/Longitude	
				Start	End
Item	Vegetation			37.796022 °	37.796022 °
				-121.358074 °	-121.358074 °
DWR ID	DWR_RD2062_02_f_2015_12				
Action/Comments					
Control annual grass and weeds on the levee slopes and easements.

View of the acceptable vegetation control on the landside levee toe.

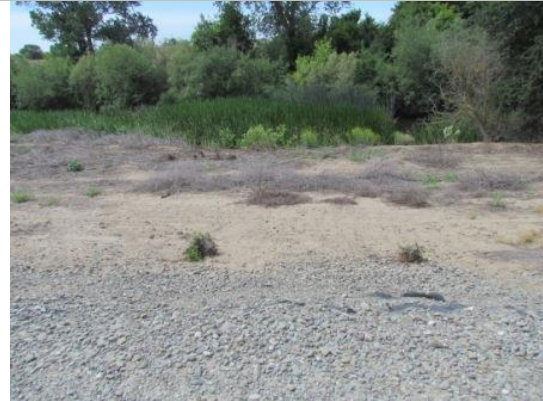
Photo 1 of 1 : FA_2015_RD2062_310_13_20150910_00003.jpg

LM Start	2.88	Rating **	N	Issue No.	13
LM End	2.88	Issue Type +	Ma	Location *	WS
Category	Earthen Levee			GPS Latitude/Longitude	
				Start	End
Item	Trim / Thin Trees			37.804060 °	37.804060
				-121.373245 °	-121.373245
DWR ID	DWR_RD2062_02_s _ 2012_13				
Action/Comments					
Tree stumps.					
Inspector Comments: Four small oak stumps on levee slope.

View of tree stumps on waterside slope. 05/17/2012

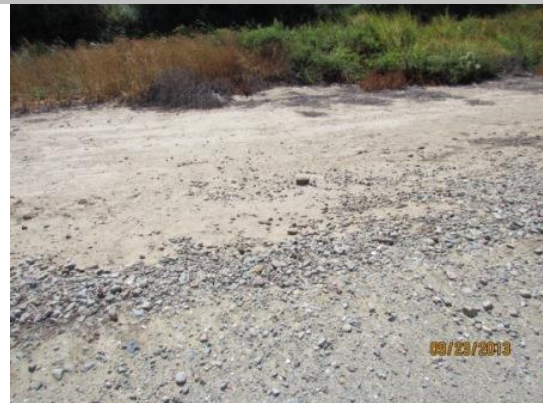
Photo 1 of 1 : FA_2015_RD2062_310_14_20150910_00004.jpg

LM Start	2.98	Rating **	N	Issue No.	14
LM End	2.98	Issue Type +	Ma	Location *	WS
Category	Earthen Levee			GPS Latitude/Longitude	
				Start	End
Item	Trim / Thin Trees			37.804452 °	37.804452 °
				-121.374903 °	-121.374903 °
DWR ID	DWR_RD2062_02_s _ 2012_14				
Action/Comments					
Tree stumps.

View of the tree stump in the middle of the photo.

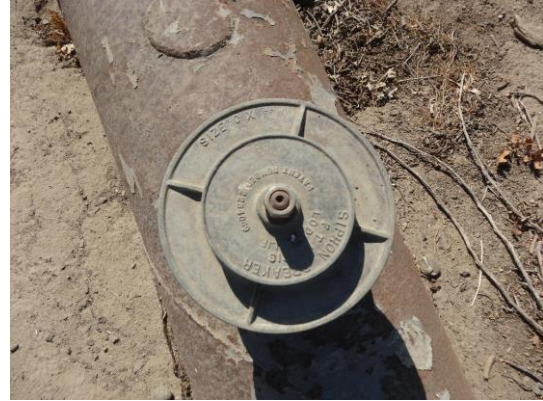
Photo 2 of 3 : UCIP_FA_2015_2024.jpg

WS view: closer view of 18-inch pipe with siphon breaker on levee slope.

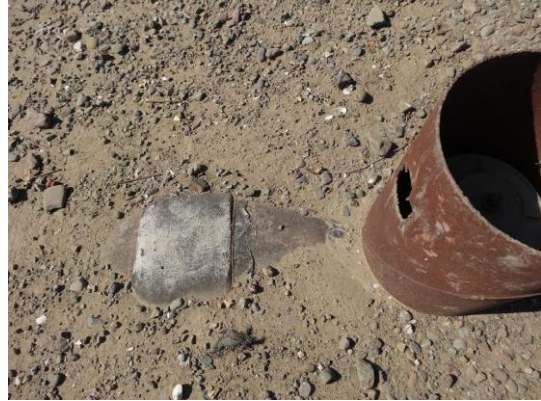
Photo 1 of 3 : UCIP_FA_2015_2215.jpg

WS view: exposed pipe and steel pipe riser on levee slope.

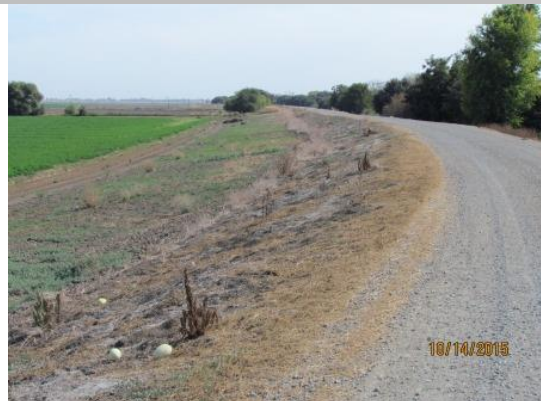
Photo 1 of 1 : FA_2015_RD2062_310_11_20151026_00012.jpg

LM Start	3.76	Rating **	A	Issue No.	11
LM End	3.76	Issue Type +	Ma	Location *	LS
Category	Earthen Levee			GPS Latitude/Longitude	
				Start	End
Item	Vegetation			37.806922 °	37.806922 °
				-121.388753 °	-121.388753 °
DWR ID	DWR_RD2062_02_f_2015_11				
Action/Comments					
Control annual grass and weeds on the levee slopes and easements.

View of the acceptable vegetation control on the landside levee slope.

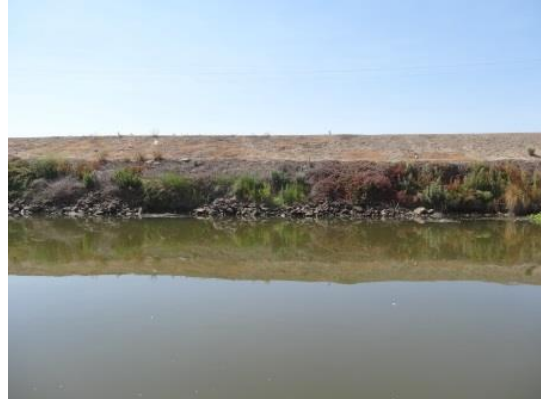
Photo 1 of 3 : SJR2015_RD2062U03RM29.93_1.jpg

Front view of the erosion.

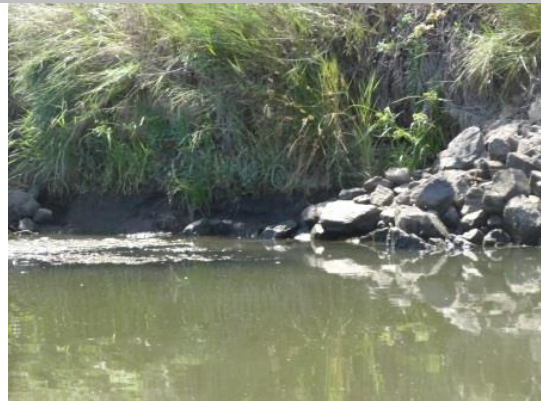
Photo 2 of 3 : SJR2015_RD2062U03RM29.93_2.jpg

Close view of the erosion.

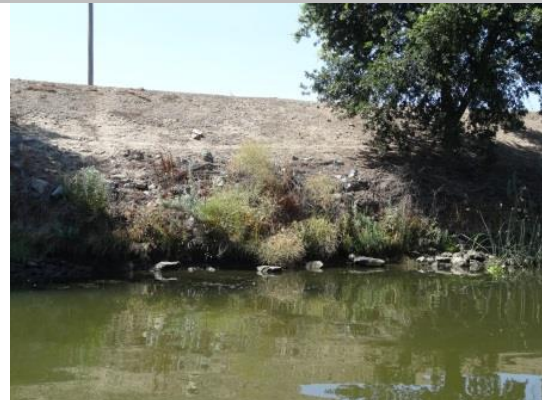
Photo 2 of 3 : SJR2015_RD2062U03RM30.02_6.jpg

Front view of the site.

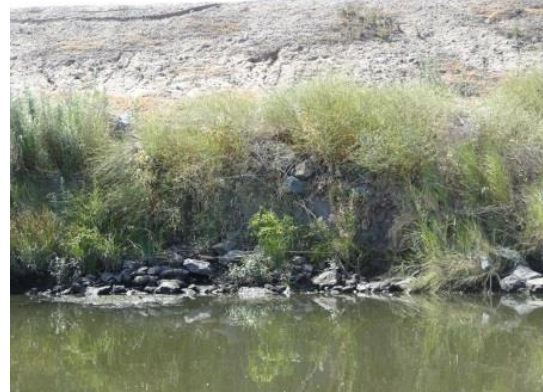
Photo 2 of 2 : SJR2015_RD2062U03RM30.10_3.jpg

LM Start	0.18	Rating **	M	Issue No.	13 (cont)
LM End	0.18	Issue Type +	Ma	Location *	WS
Category	Supplemental			GPS Latitude/Longitude	
				Start	End
Item	DWR Erosion Survey			37.810468 °	37.810468 °
				-121.387492 °	-121.387492 °
DWR ID					
Action/Comments					
Inspector Comments: 06/25/2015: No significant change observed. 07/02/2014: No significant change observed. 08/13/2013: No significant change observed. 08/07/2012: The site has been visited by boat survey. No significant change observed 08/23/2011: The protection at the levee toe has been washed away. [2015 Site ID:RD2062U03RM30.1]

Close view of the erosion.

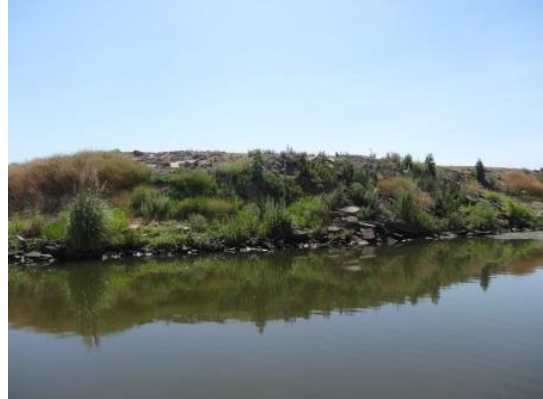
Photo 1 of 3 : SJR2015_RD2062U03RM30.43_2.jpg

Front view of the site.

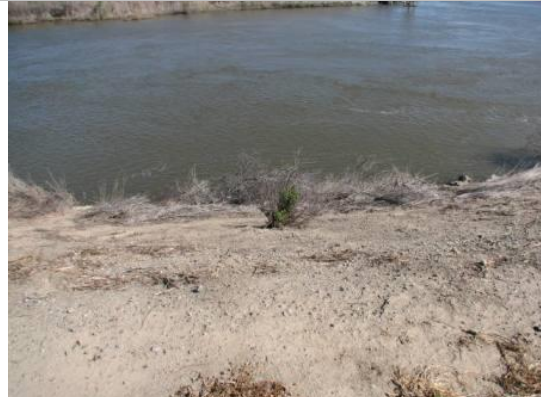
Photo 1 of 1 : FA_2015_RD2062_311_10_20150910_00009.jpg

LM Start	0.61	Rating **	N	Issue No.	10
LM End	0.61	Issue Type +	Ma	Location *	WS
Category	Earthen Levee			GPS Latitude/Longitude	
				Start	End
Item	Trim / Thin Trees			37.813570 °	37.813570 °
				-121.382094 °	-121.382094 °
DWR ID	DWR_RD2062_03_s_2012_10				
Action/Comments					
Tree stumps.					
Inspector Comments: Stump in slope.

05/11/2011 Stump in slope, new growth in center of photo is at the location of the stump.

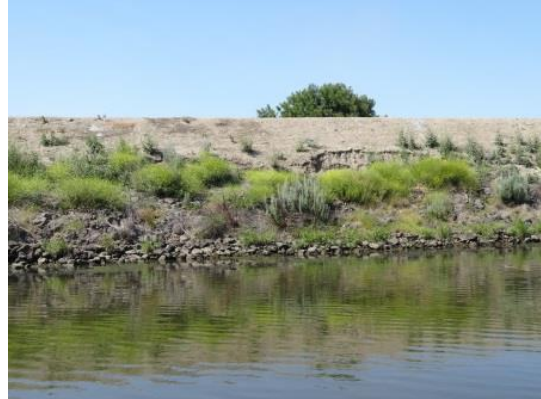
Photo 2 of 2 : SJR2015_RD2062U03RM31.12_3.jpg

LM Start	1.18	Rating **	U	Issue No.	4 (cont)	
LM End	1.19	Issue Type +	Ma	Location *	WS	
Category	Supplemental			GPS Latitude/Longitude		
				Start	End	
Item	DWR Erosion Survey			37.819290 °	37.819290 °	
				-121.378880 °	-121.378880 °	
DWR ID						
Action/Comments						
Inspector Comments: 06/25/2015: No significant change observed. 07/02/2014: No significant change observed. 08/13/2013: No significant change observed. 08/07/2012: The site has been visited by boat survey. No significant change observed 08/23/2011: No significant change observed on site. 09/07/2010: No significant change observed on site. Much of the seasonal grass along the slope was cleared. Site consists of an existing scalloped erosion approximately 30 feet long by 5 feet wide at its widest opening. The lateral crack is extended outwards along the middle slope. There is a 1 to 2 feet of differential settlement that could further develop into a shallow slide. 08/06/2010: Recommended as local maintenance issue, per CLRO. 03/09/2010: As discussed with Michael Moncrief of MBK Engineer, site will be 'addressed' this year. 09/28/2009: No major change observed; section of rip rap has slipped, creating a terraced effect; dense vegetation growth; recommended as a local maintenance issue, per CLRO CES Evaluation 2008 Report; Site # is the same as RM31.12,LM1.25; previously rated "U". 09/14/2006: 1-2' into prism. [2015 Site ID:RD2062U03RM31.12]

Front view of the site.

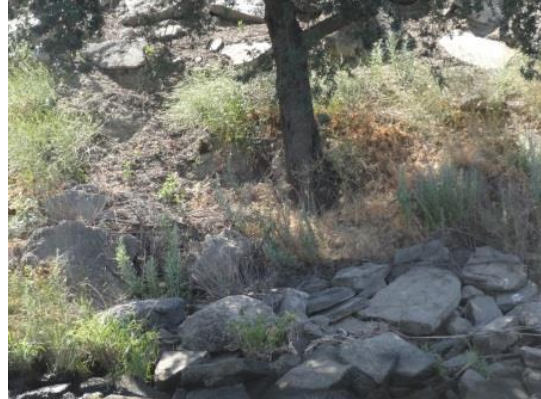
Photo 2 of 3 : SJR2015_RD2062U03RM31.28_3.jpg

11/05/2008: Portion of rip rap collapsing.
 09/14/2006: Portion of rip rap along the slope has collapsed; exposed levee section is starting to erode, exposing roots from the nearby tree.
 [2015 Site ID:RD2062U03RM31.28]

A closer view of the site.

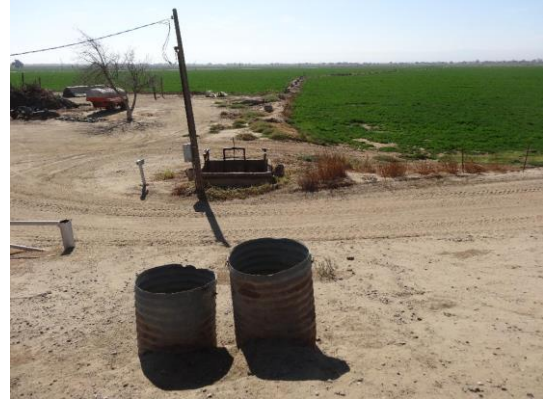
Photo 1 of 3 : UCIP_FA_2015_2224.jpg

LS view: two CMP risers on levee slope, concrete distribution box, and service pole across the dirt road, off the levee toe.

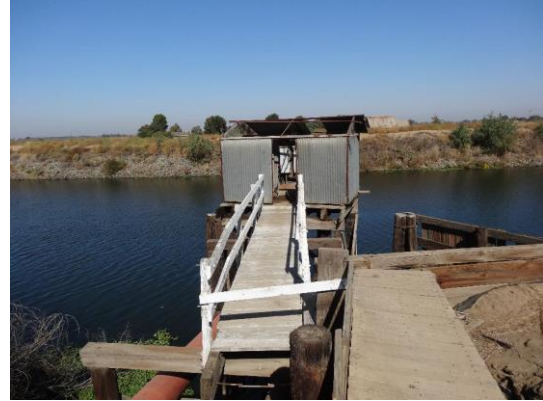
Photo 3 of 3 : UCIP_FA_2015_2226.jpg

WS view: wooden walkway to pumphouse, pumphouse on wooden pile structure in the stream.

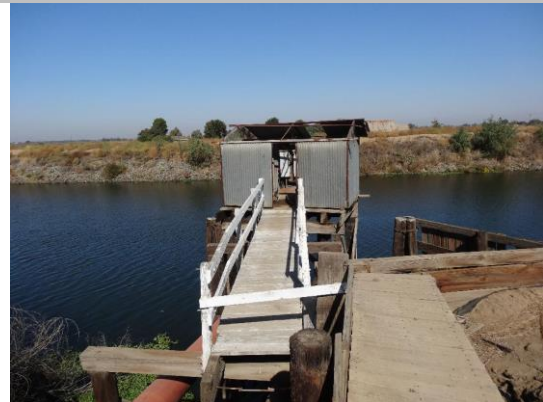
Photo 3 of 3 : UCIP_FA_2015_2103.jpg

WS view: wooden walkway to pumphouse, pumphouse on wooden pile structure in the stream.

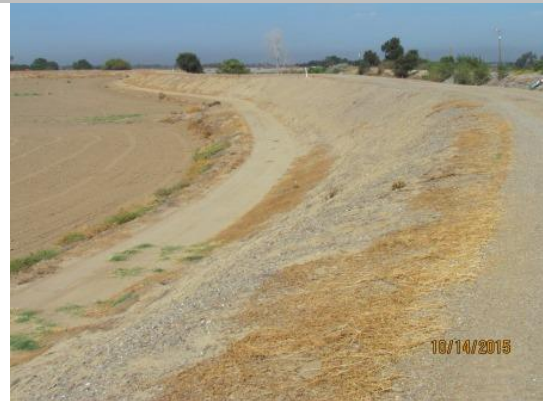
Photo 1 of 1 : FA_2015_RD2062_311_29_20151026_00025.jpg

LM Start	4.40	Rating **	A	Issue No.	29
LM End	4.40	Issue Type +	Ma	Location *	LS
Category	Earthen Levee			GPS Latitude/Longitude	
				Start	End
Item	Vegetation			37.818540 °	37.818540 °
				-121.334073 °	-121.334073 °
DWR ID	DWR_RD2062_03_f_2015_29				
Action/Comments					
Control annual grass and weeds on the levee slopes and easements.

View of the acceptable vegetation control on the landside levee slope.

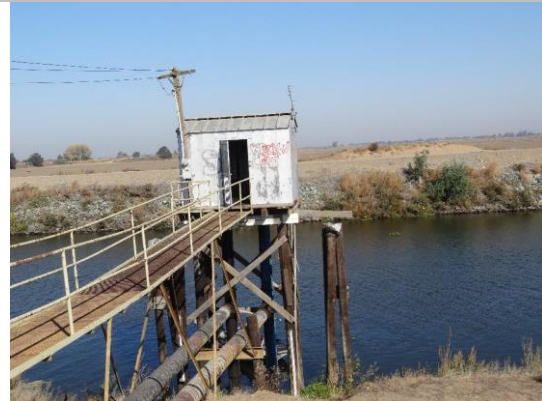
Photo 1 of 3 : UCIP_FA_2015_2221.jpg

LM Start	5.37	Rating **	M	Issue No.	39
LM End	5.37	Issue Type +	En	Location *	LS
Category	Supplemental			GPS Latitude/Longitude	
				Start	End
Item	DWR UCIP Field Study			37.807305 °	37.807305 °
				-121.331290 °	-121.331290 °
DWR ID					
Action/Comments					
Inspector Comments: FS_ID:23142 DS_ID:19203 EP_NO: N/A FS_HLM: 5.449 Repair Type: Non-Urgent Crossing Status: Found UCIP Comments: - siphon breakers not protected.- flow meter and gage station on waterside.- pump house on wooden pile structure. Walkway to the pumphouse. FIELD_STRUCT_DESC: 1 of 2: Two 16-inch pipes through the levee 4.0 feet below the crown. Pump in the pump house on pile structure in the stream. Siphon breakers on the landward slope. Concrete distribution box on landside berm. FS Date: 10/22/2013

WS view: pump house on wooden pipe structure in the stream. Two steel pipes under the walkway.

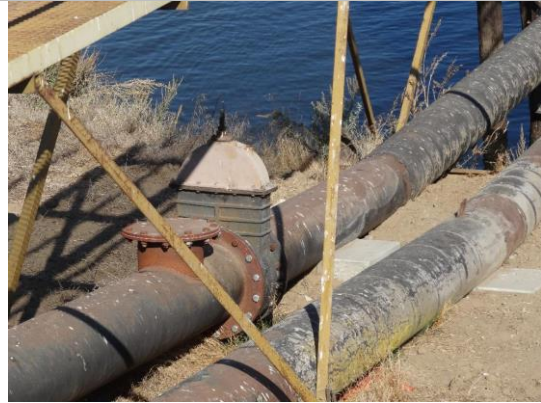
Photo 2 of 3 : UCIP_FA_2015_2222.jpg

WS view: two 16-inch pipes under walkway. Gate valve without handle on one of the pipes.

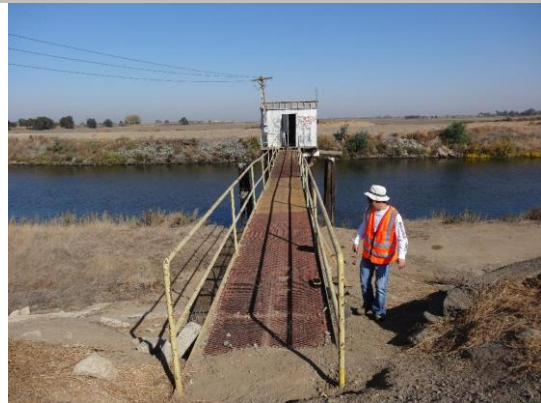
Photo 3 of 3 : UCIP_FA_2015_2223.jpg

WS view: steel walkway to pump house in the stream.

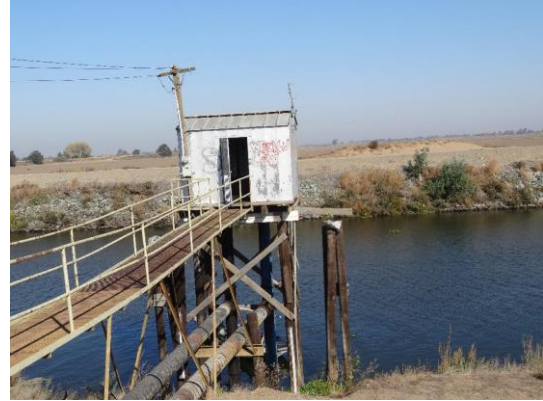
Photo 1 of 3 : UCIP_FA_2015_2176.jpg

LM Start	5.37	Rating **	M	Issue No.	40
LM End	5.37	Issue Type +	En	Location *	LS
Category	Supplemental			GPS Latitude/Longitude	
				Start	End
Item	DWR UCIP Field Study			37.807305 °	37.807305 °
				-121.331276 °	-121.331276 °
DWR ID					
Action/Comments					
Inspector Comments: FS_ID:23140					
DS_ID:19206					
EP_NO: N/A					
FS_HLM: 5.45					
Repair Type: Non-Urgent					
Crossing Status: Found

WS view: pump house on wooden pipe structure in the stream. Two steel pipes under the walkway.

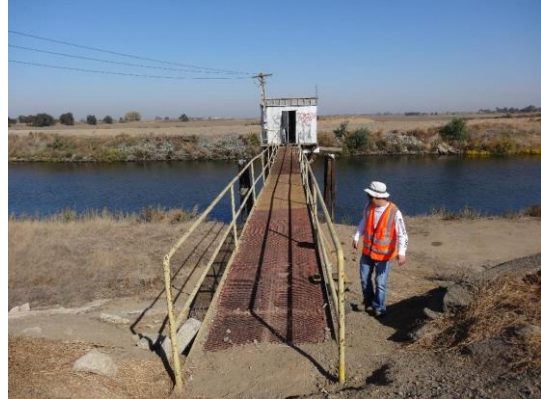
Photo 3 of 3 : UCIP_FA_2015_2178.jpg

WS view: steel walkway to pump house in the stream.
